Slip 4 Additional Data Collection

Duwamish Sediment Other Area and Southwest Bank

Corrective Measure and Habitat Project

Boeing Plant 2, Seattle/Tukwila, Washington

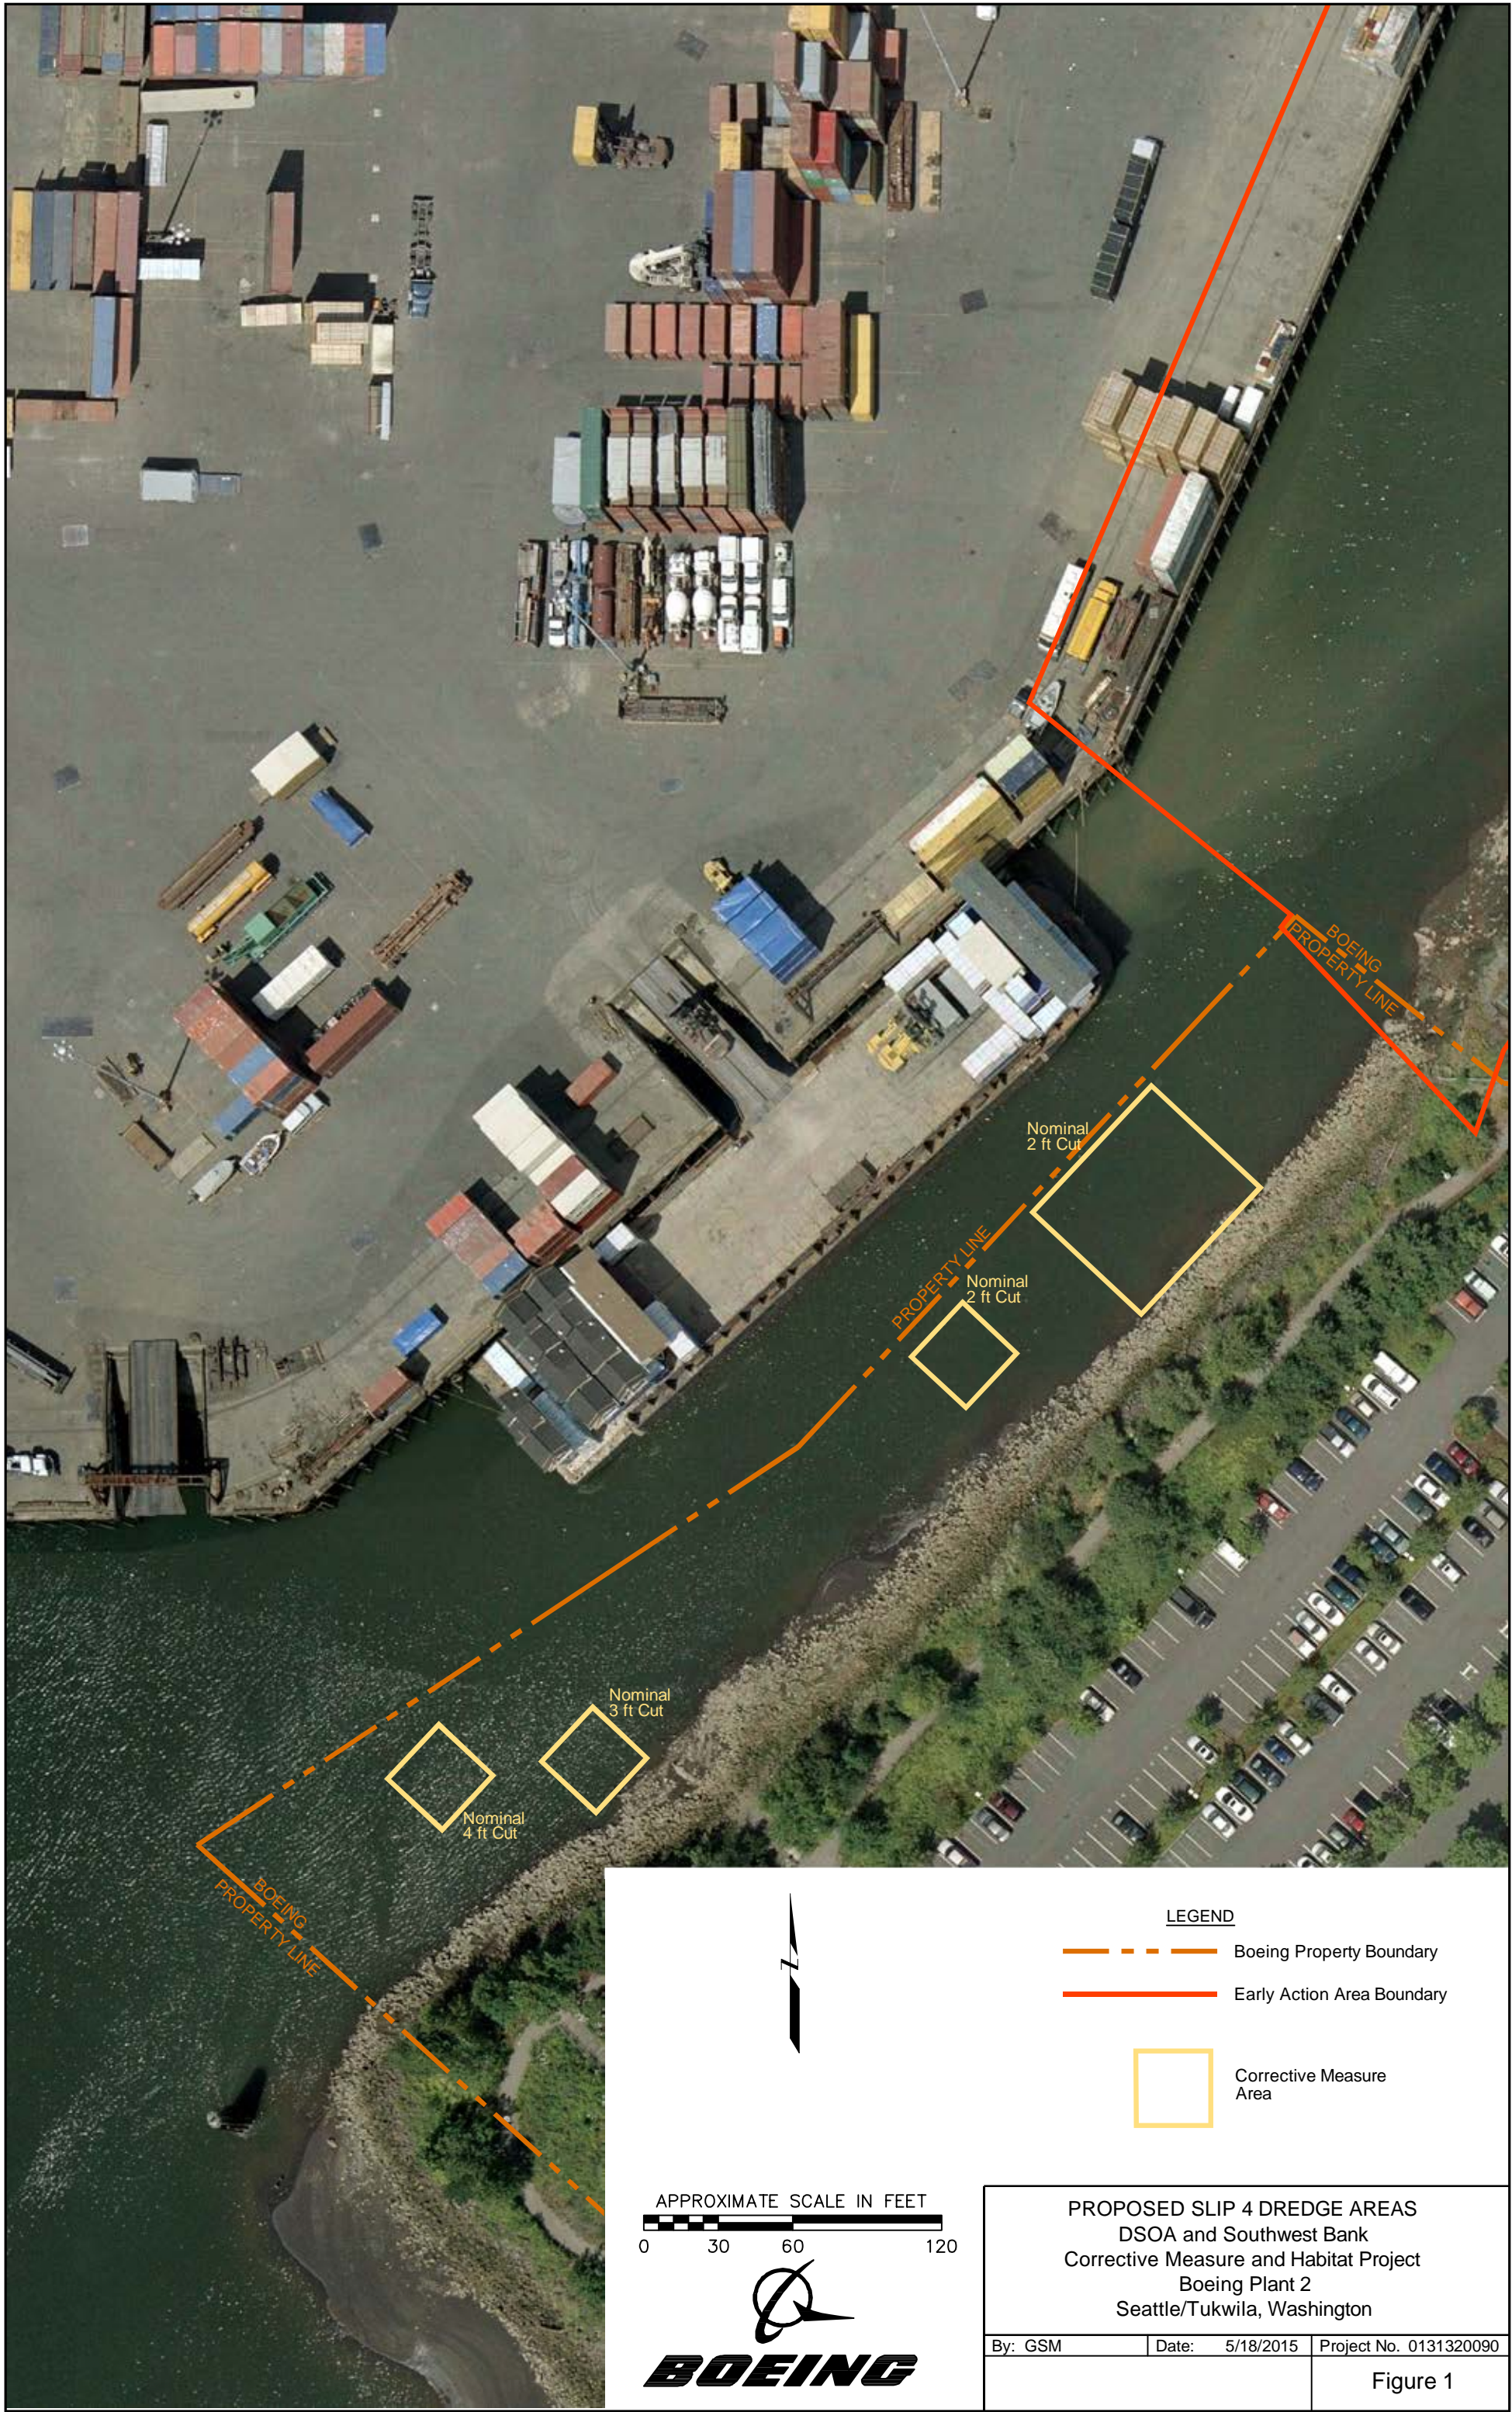
As part of the Duwamish Sediment Other Area (DSOA) Corrective Measure, EPA identified four small areas within Slip 4 to be dredged (see Figure 1). A review of the Slip 4 data was provided in Appendix N of the Corrective Measure Alternatives Study (AMEC and FSI 2011). The dredge depths in the four areas were a nominal 2, 3, or 4 feet, based on existing data or weight of evidence. EPA also required post-construction/pre-backfill core samples to be collected within the footprint of each of the four dredge areas (Post-Construction Core Sampling Work Plan; AMEC et al. 2012).

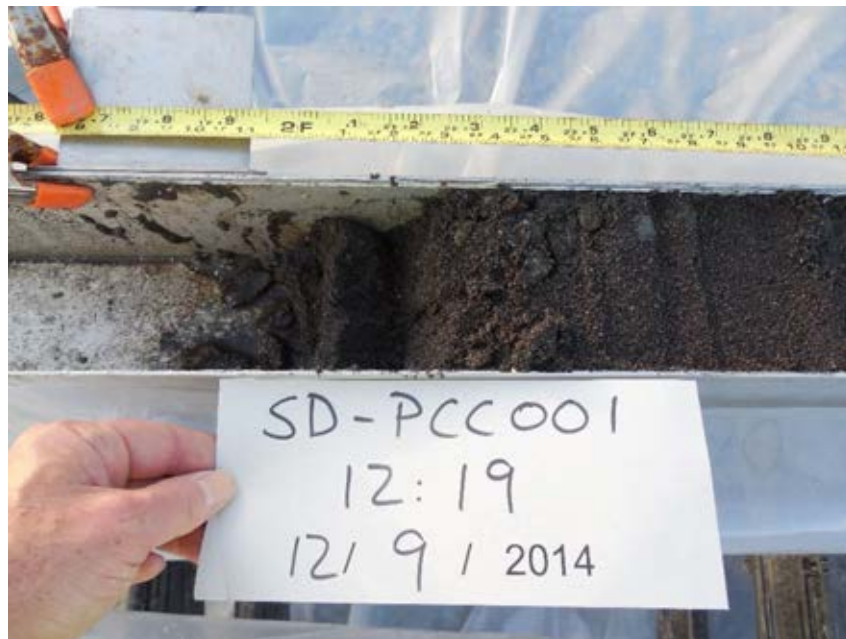
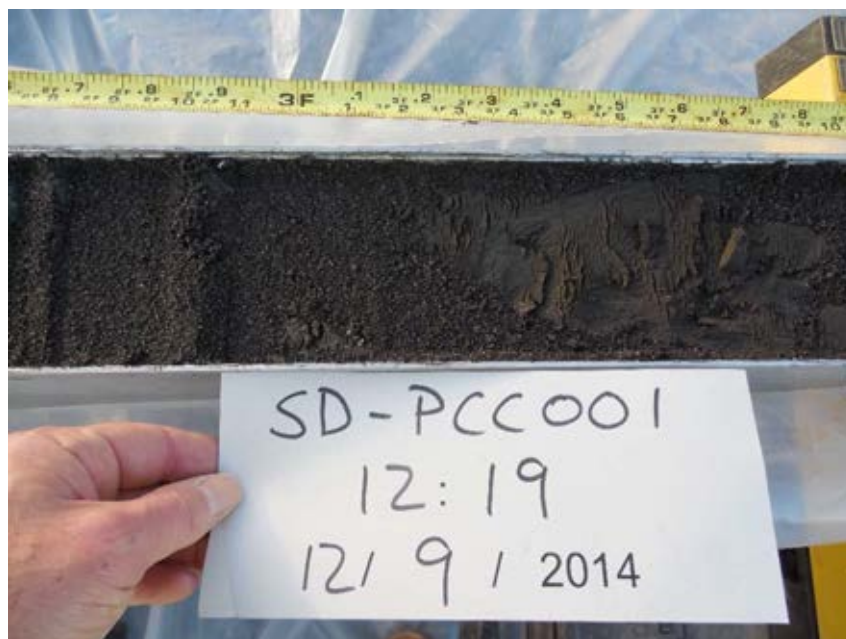
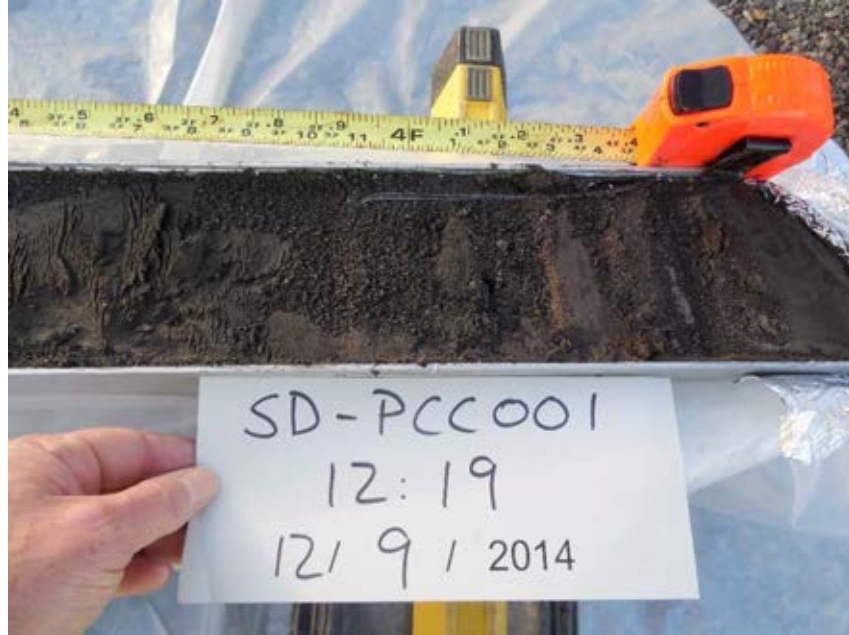
Station SD-PCC001

Depth below mudline (ft.)	Visual Description of Sediment	Summary Interpretation	Sample ID No.
0.0	Moist medium brown fine SAND with a trace of gravel (rounded 3/4 minus)		SD-PCC001-A
0.5			SD-PCC001-B
1.0			
1.5			SD-PCC001-C
2.0	Moist medium brown fine SAND with a large silt inclusion (medium brown sandy silt) between 1.9 and 3.8 ft bgs		
2.5			SD-PCC001-D
3.0			
3.5	Dry medium brown Silt layer , very firm		
4.0	Moist medium brown fine SAND layer with scattered silt inclusions		
	Dry medium brown SILT layer very firm		
	End of Core	End of Core	
4.5

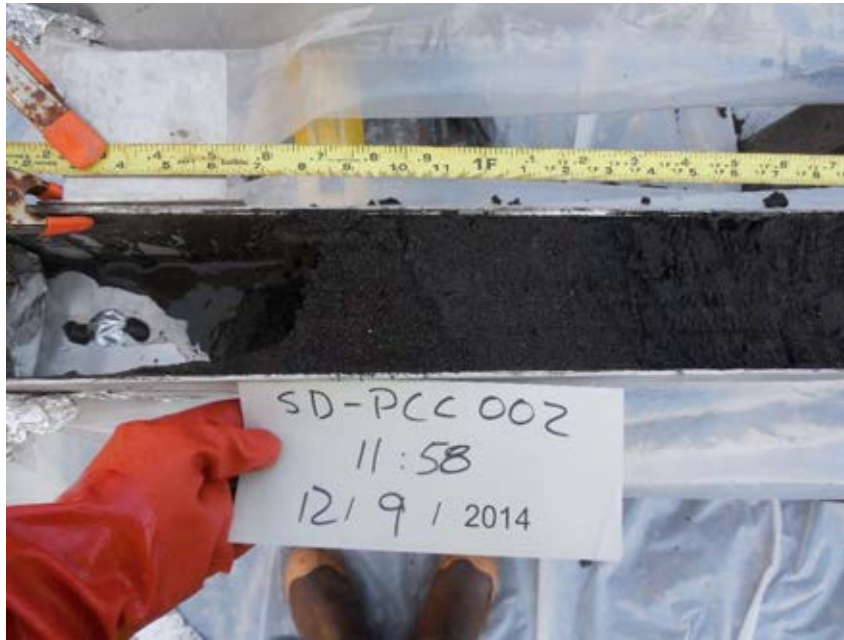
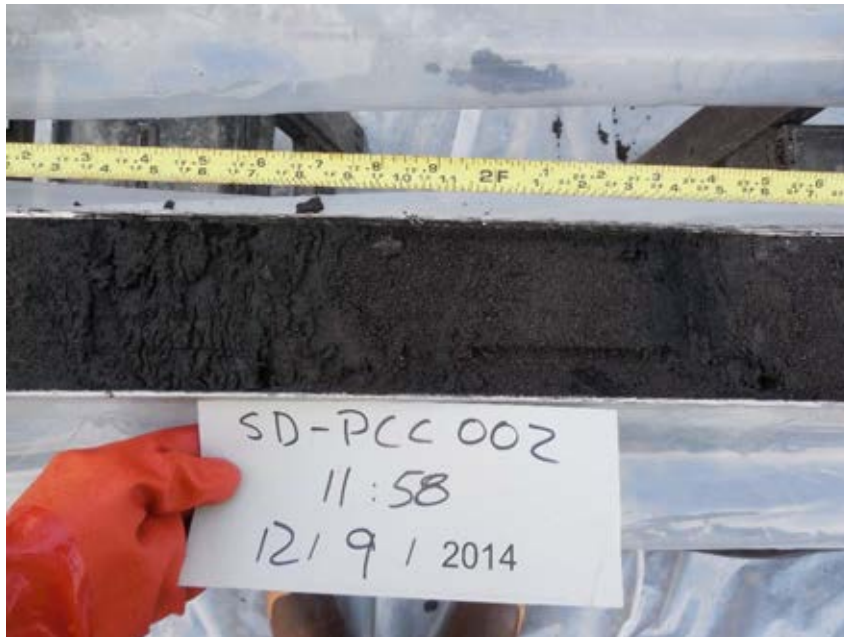
Station SD-PCC002

Depth below mudline (ft.)	Visual Description of Sediment	Summary Interpretation	Sample ID No.
0.0	Moist dark brown fine SAND with a trace plant material		SD-PCC002-A
0.5			
1.0	Moist dark gray to black sandy SILT		SD-PCC002-B
1.5	Moist dark brown fine SAND with silt, trace of gravel (rounded)		SD-PCC002-C
2.0	Dark gray to black SILT lense		
2.5	Moist dark brown fine SAND, silt inclusion at 2.2 to 2.6 ft bgs		SD-PCC002-D
3.0			
3.5	SILT lense (medium brown) at top of fine SAND unit with trace of wood debris		
4.0	End of sediment		
4.5	End of Core	End of Core	End of Core
5.0

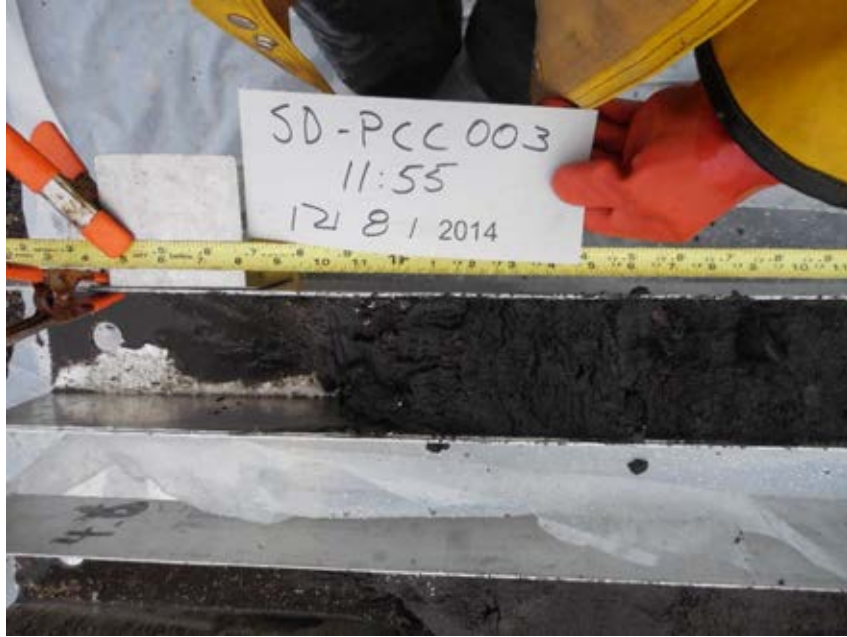
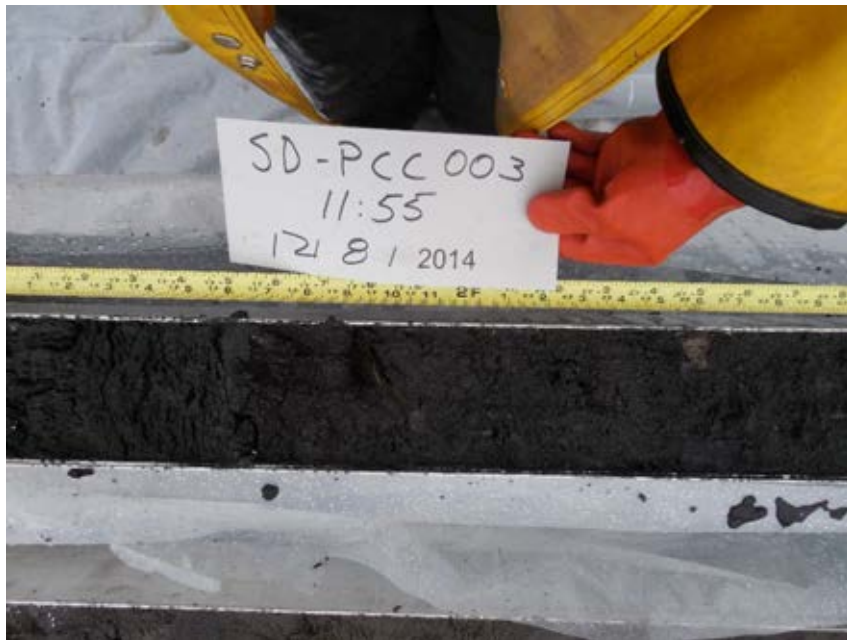
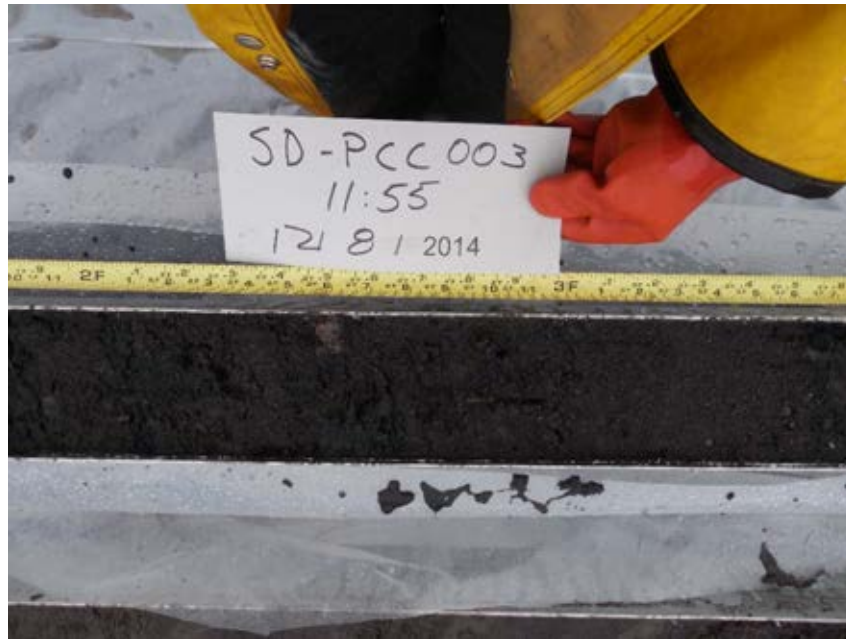
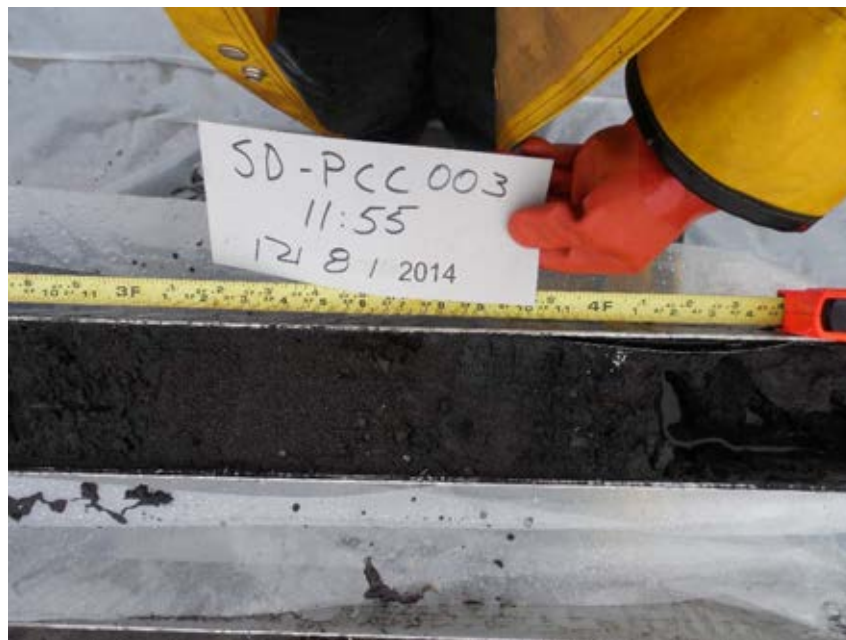
Station SD-PCC003

Depth below mudline (ft.)	Visual Description of Sediment	Summary Interpretation	Sample ID No.
0.0	Trace of surface silt, wet dark gray SAND with silt interbedded with sandy silt, trace of wood debris		SD-PCC003-A
0.5			SD-PCC003-B
1.0	Moist dak gray fine silty SAND with scattered silt inclusions, trace of wood debris		SD-PCC003-C
1.5			SD-PCC003-D
2.0	Moist dark gray fine SAND with scattered silt inclusions, trace of coarse sand.		
2.5			
3.0			
3.5			
4.0			
4.5		End of Core	End of Core
5.0

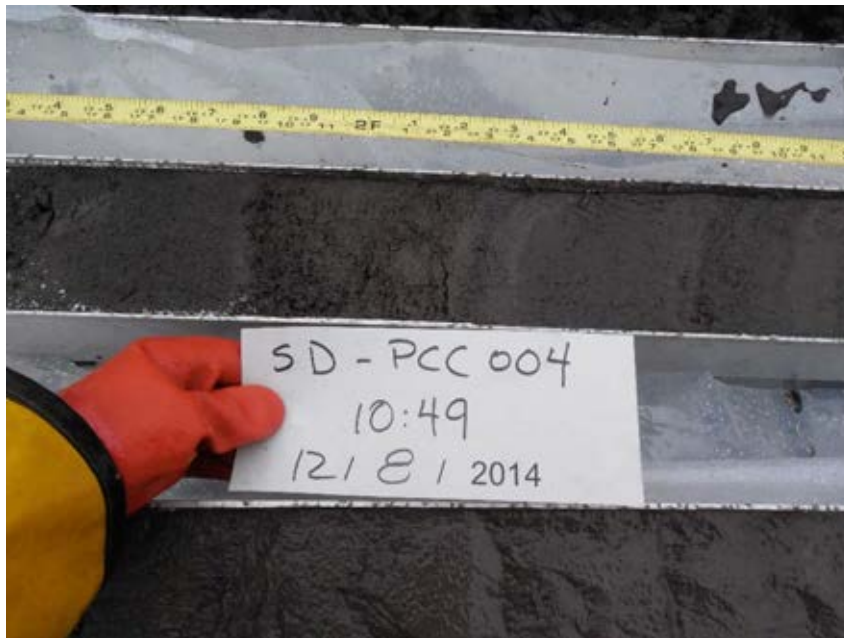
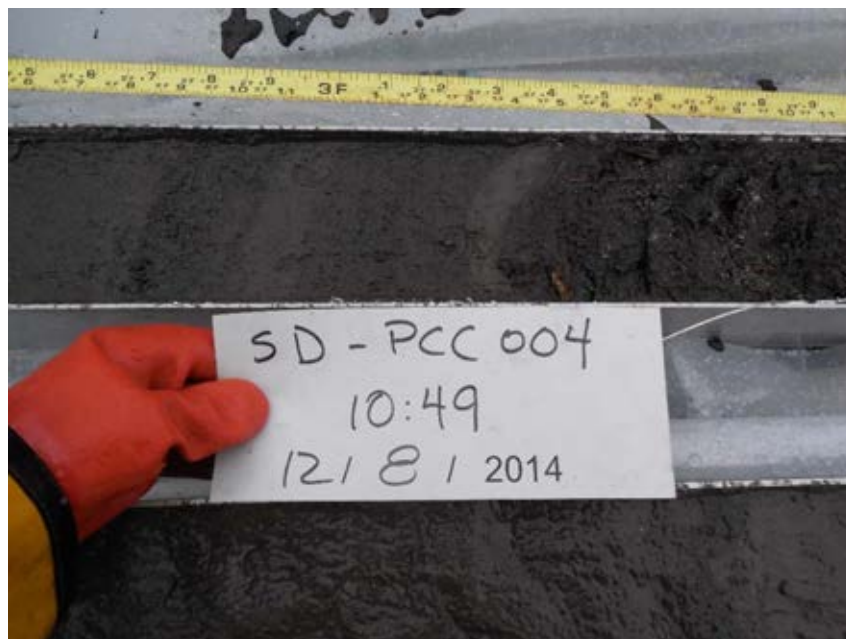
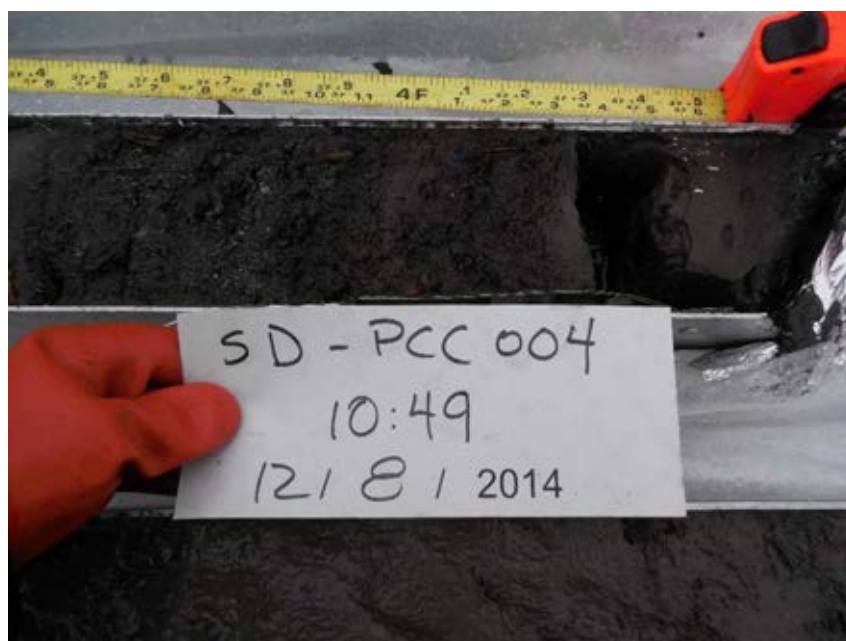
Station SD-PCC004

Depth below mudline (ft.)	Visual Description of Sediment	Summary Interpretation	Sample ID No.
0.0			SD-PCC004-A
0.5	Chunk of wood on surface (2x3 in). Medium gray, moist fine SAND with trace of silt.		
1.0			SD-PCC004-B
1.5	Moist medium gray silty fine SAND with trace of wood debris		
2.0			SD-PCC004-C
2.5	Moist medium gray interbedded fine SAND with scattered silt layers		
3.0			SD-PCC004-D
3.5	Moist dark gray medium SAND with 20% wood debris and plant material, interbedded silt layers.		
4.0			
4.5	End of sediment		
5.0	End of Core	End of Core	End of Core

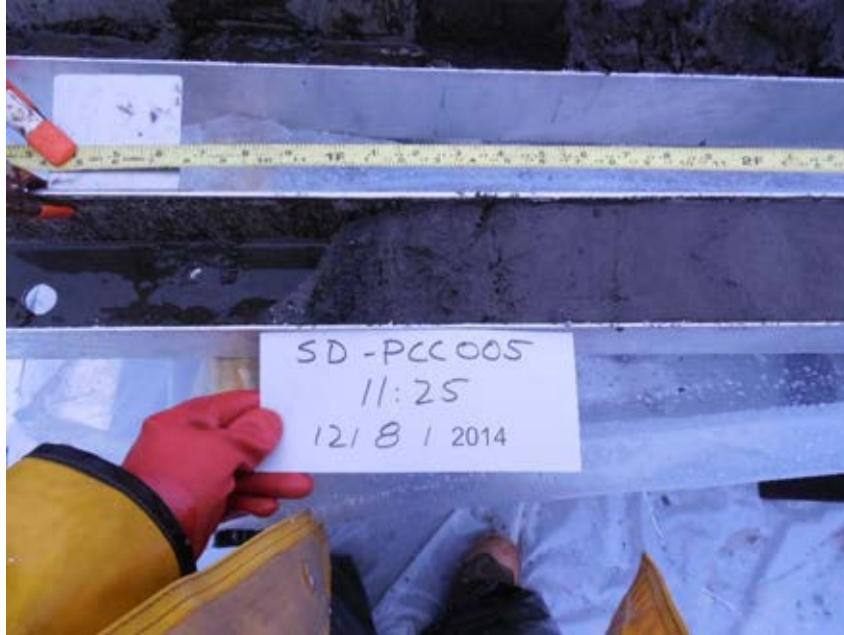
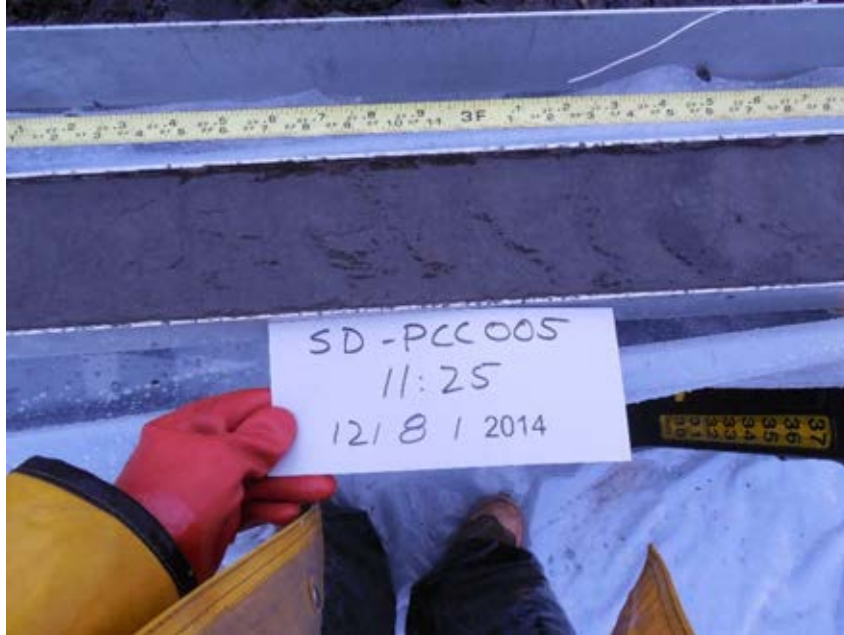
Station SD-PCC005

Depth below mudline (ft.)	Visual Description of Sediment	Summary Interpretation	Sample ID No.
0.0	Trace of surface silt, wet dark gray fine to medium silty SAND		SD-PCC005-A
0.5			SD-PCC005-B
1.0			
1.5			SD-PCC005-C
2.0			
2.5	Moist medium gray interbedded layers of fine silty SAND and sandy SILT.		SD-PCC005-D
3.0			
3.5			
4.0			
4.5	End of Core	End of Core	End of Core
5.0

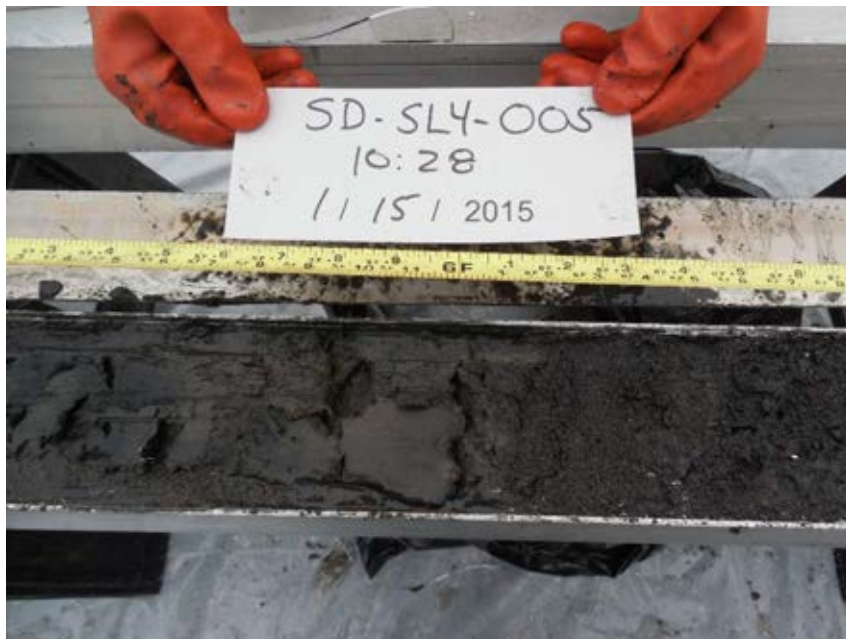
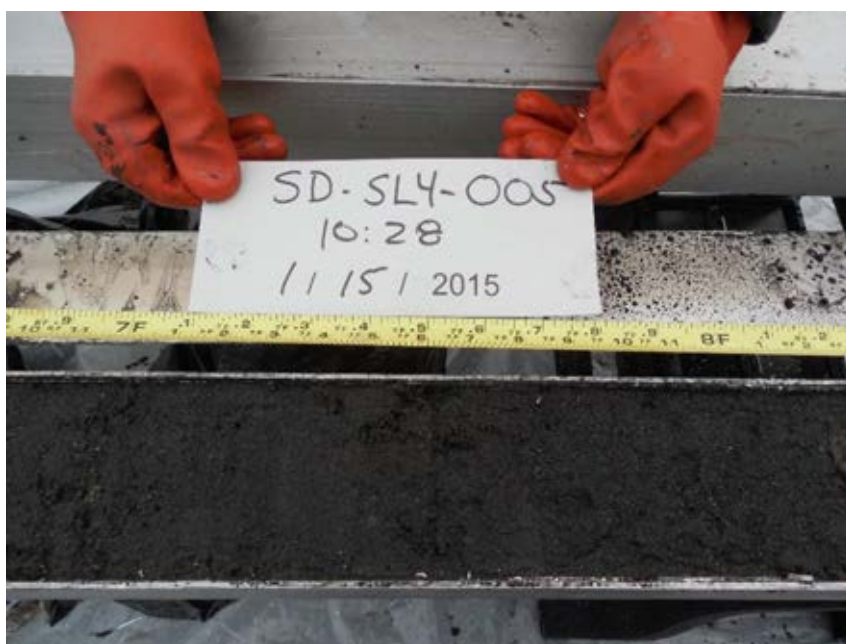
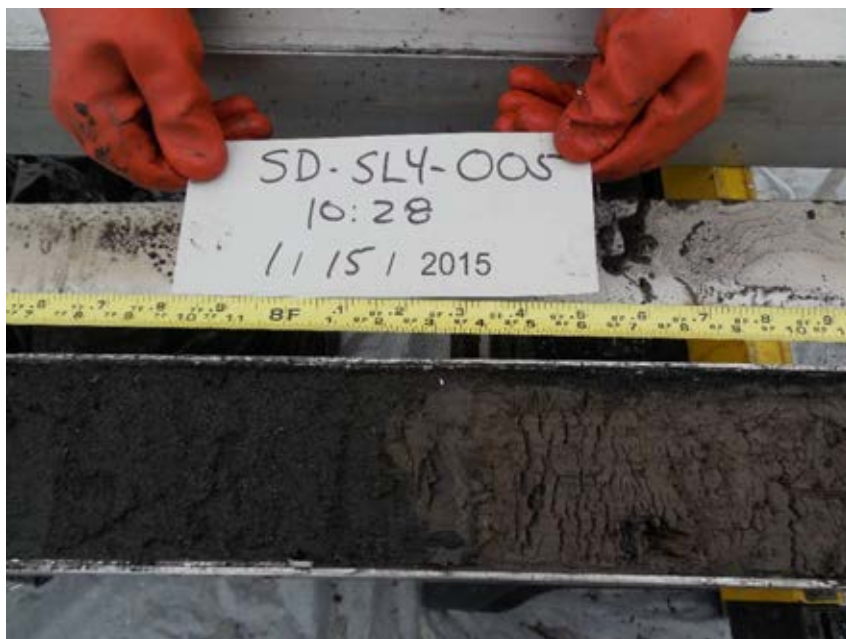
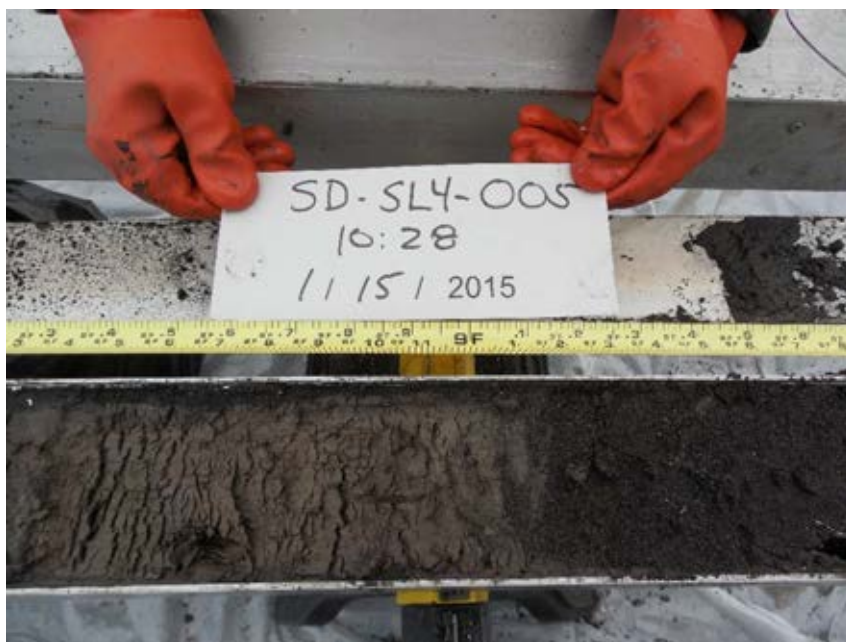
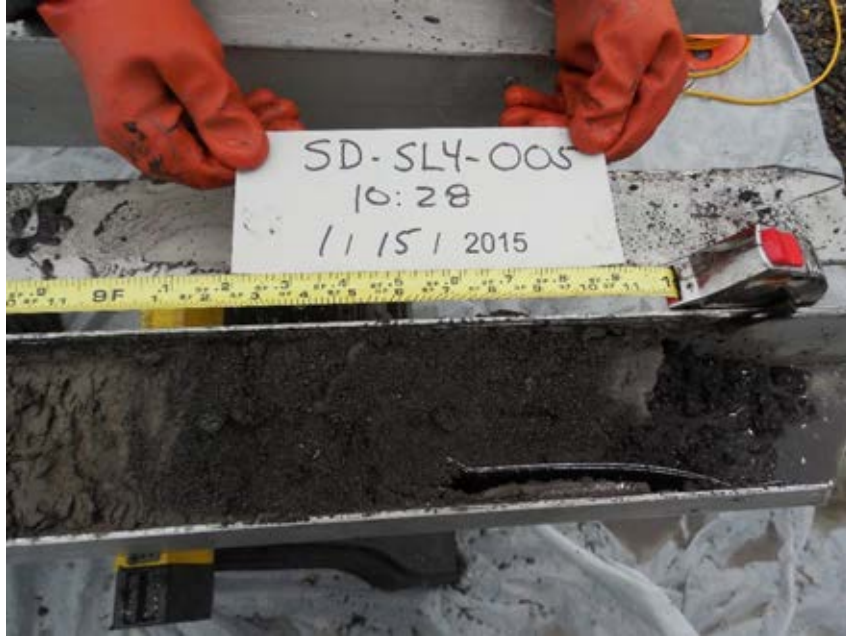
Station SD-SL4-005

Depth below mudline (ft.)	Visual Description of Sediment	Summary Interpretation	Sample ID No.
0.0	Moist dark gray fine SAND.		SD-SL-005-0000
1.0	Wet soft dark gray to black SILT with plant matter.		SD-SL-005-0010
2.0			SD-SL-005-0020
3.0	Moist becoming drier with depth, dark gray fine SAND with scattered silt inclusions. Thin layer of medium to coarse sand with gravel layer at 3.5 ft bgs		SD-SL-005-0030
4.0			SD-SL-005-0040
5.0	Firm medium brown SILT layer with traces of plant and wood debris		SD-SL-005-0050
6.0	Dark gray fine SAND with a trace of brown silt		SD-SL-005-0060
7.0	End of sediment		
	End of Core	End of Core	End of Core
8.0

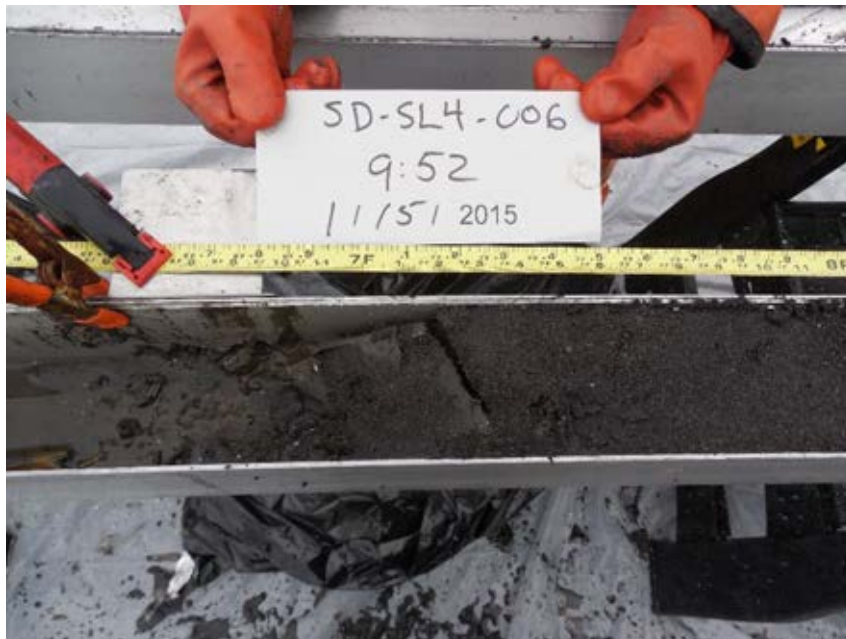
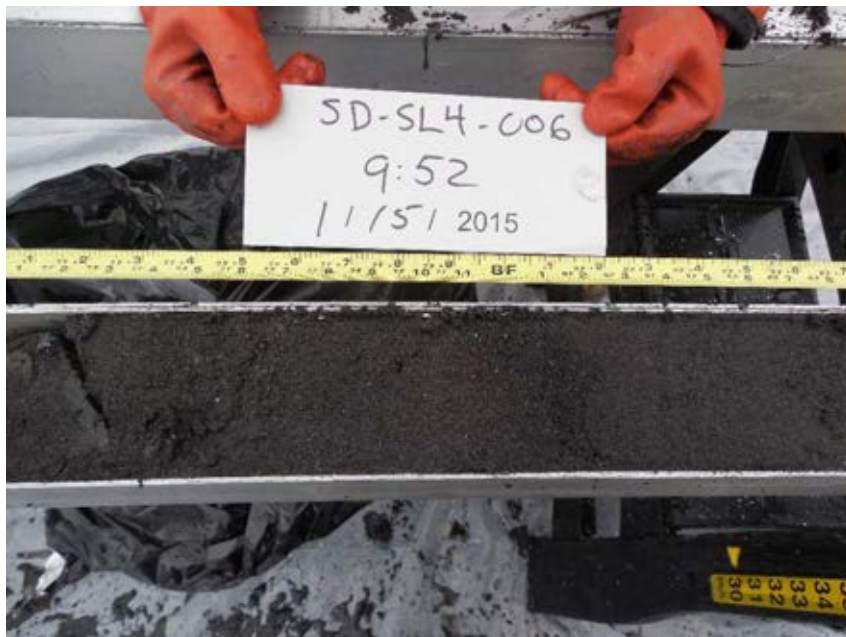
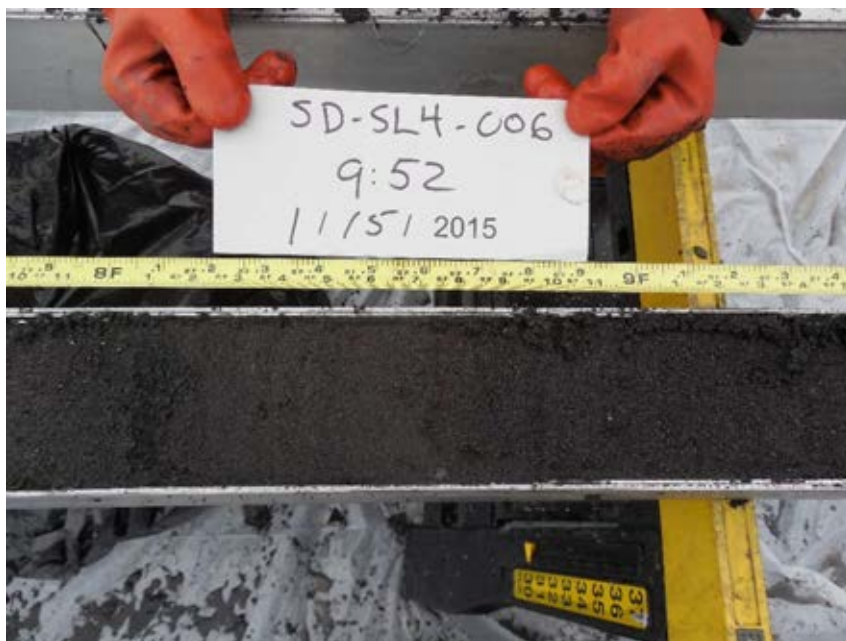
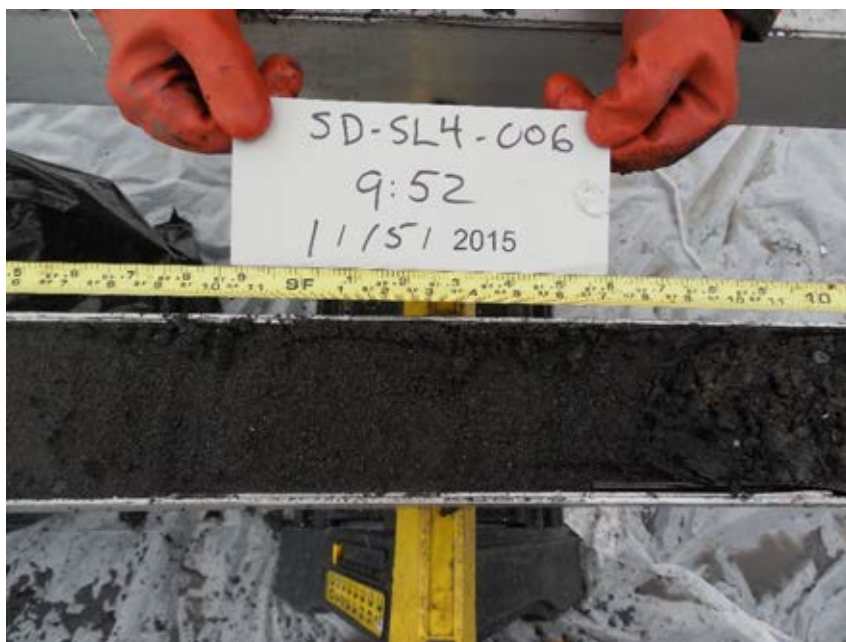
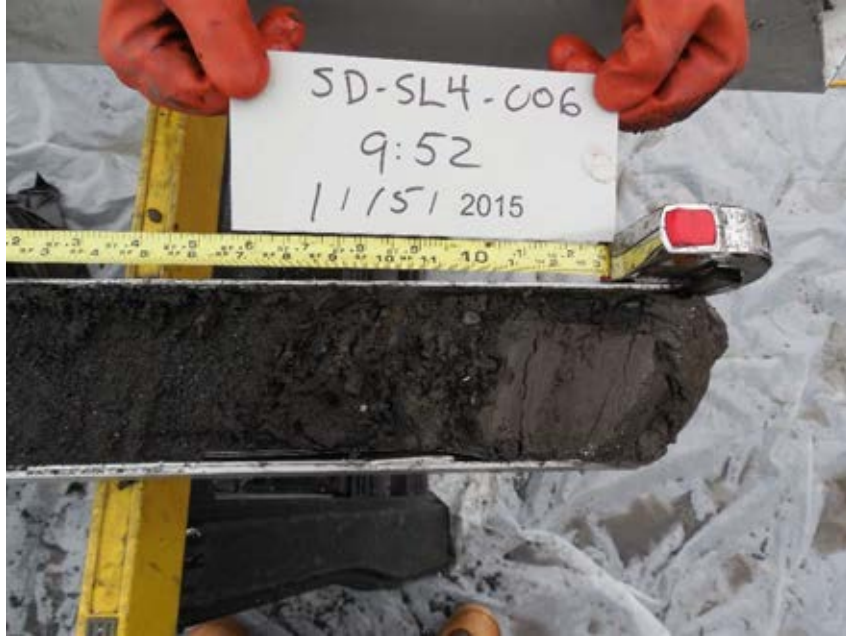
Station SD-SL4-006

Depth below mudline (ft.)	Visual Description of Sediment	Summary Interpretation	Sample ID No.
0.0	Surface layer of woody debris then moist dark gray fine SAND with a trace of gravel, large chunk of wood at 5 ft bgs		SD-SL-006-0000
1.0			SD-SL-006-0010
2.0			SD-SL-006-0020
3.0			SD-SL-006-0030
4.0			SD-SL-006-0040
5.0	Moist medium brown SILT with 50% wood and plant material, trace gravel (rounded)		SD-SL-006-0050
6.0			SD-SL-006-0060
6.7	Dry firm medium brown silty AND and sandy SILT		
7.0	End of Core	End of Core	End of Core

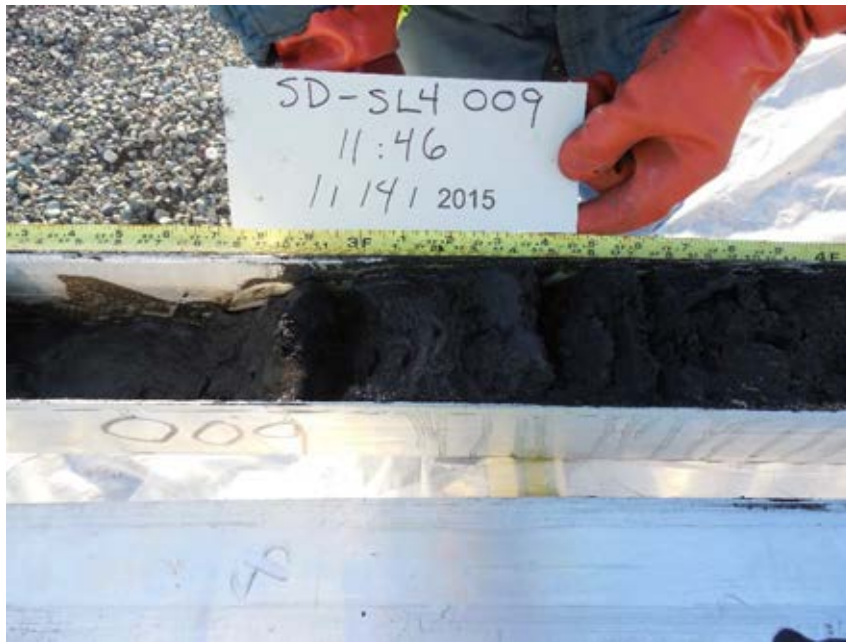
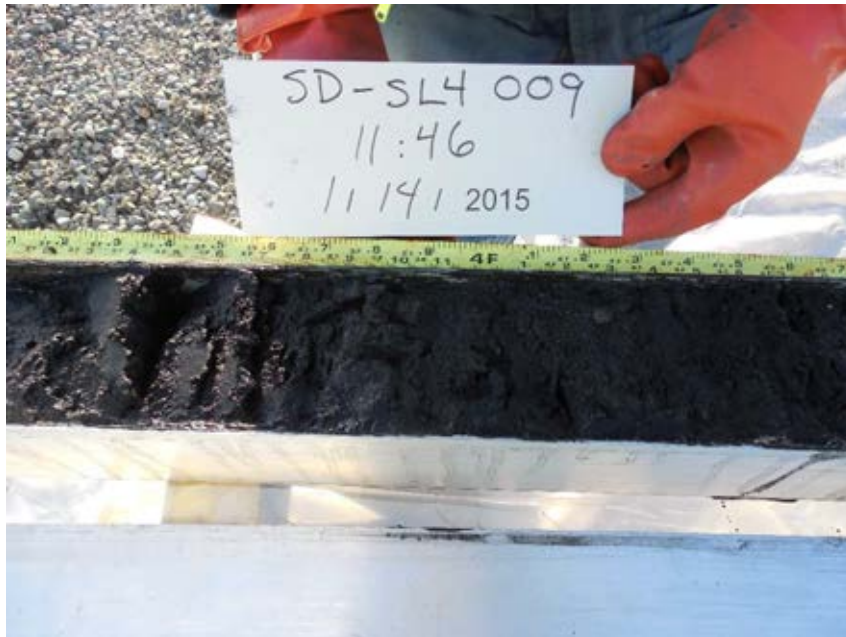
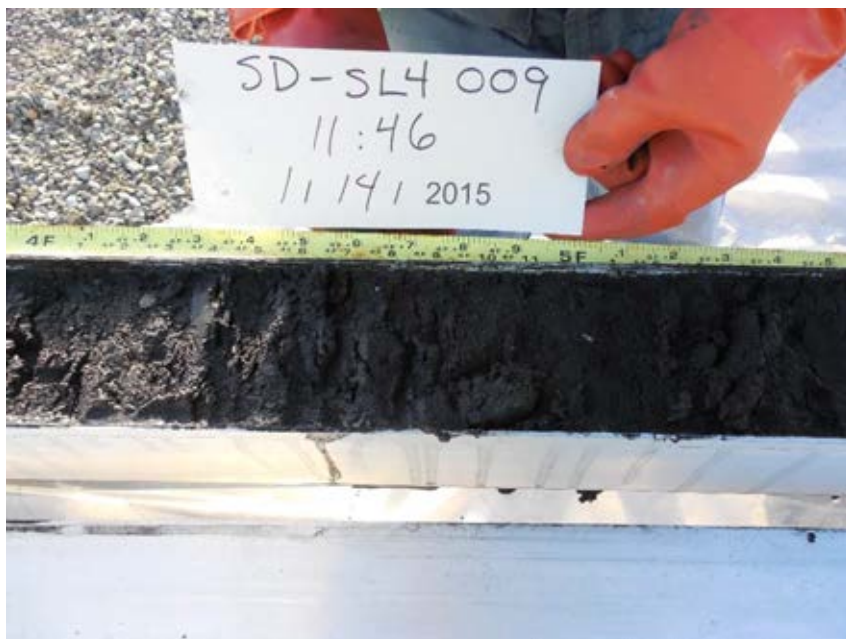
Station SD-SL4-009

Depth below mudline (ft.)	Visual Description of Sediment	Summary Interpretation	Sample ID No.
0.0	Wet black SILT, very soft becoming firmer with depth, percentage of fine sand increasing with depth.		SD-SL-009-0000
1.0			SD-SL-009-0010
2.0	Moist dark gray to black fine silty SAND, scattered gravel (rounded) at 2.2 ft bgs		SD-SL-009-0020
3.0			SD-SL-009-0030
4.0			SD-SL-009-0040
5.0	Lense (1 in) of firm dark gray to black SILT then moist dark gray to black fine sity sand and interbedded layers of sandy silt		SD-SL-009-0050
6.0			SD-SL-009-0060
7.0			SD-SL-009-0070
8.0	Dark gray to brown fine SAND with scattered interbedded layers of brown silt, fine sand has reddish grains		SD-SL-009-0080
9.0	End of Sediment
